VERO BEACH MUSEUM OF ART
Renovation and Risk Analysis
FINAL REPORT

April 9, 2021

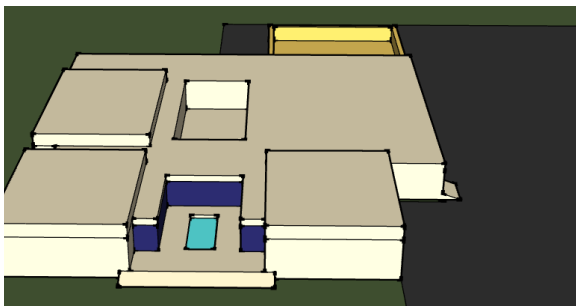
1986
ORIGINAL BUILDING

Legends Project Development was asked to prepare a report that identifies the climate hazards which pose a risk to the mission and ongoing operations of VBMA as well as propose mitigation strategies to consider. The location of the museum presents ongoing operational challenges due to the climate risks inherent with its proximity to the coast, and flood prone site. The museum itself has undergone several renovations and additions over the years, which has led to inconsistent building systems and an overall “patchy” feel. In concurrence with developing options for reducing the risks from climate hazards, LPD will also address the museum’s overall design challenges associated with the current facility, and with input from VBMA, propose options for improvements. The museum lacks a physical cohesiveness that has led to inefficiencies and inadequacies for programming. Since opening in 1986, there have been several additions and renovations to the building and site occurring in 1999, 2007 and 2012.

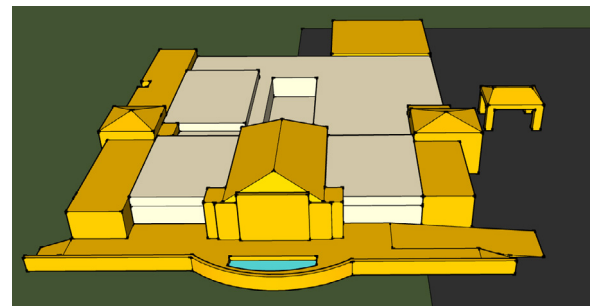
1999
ADDED GALLERY SPACE, REALIGNED
NORTH ENTRY WITH PARKING LOT
AND ADDED PORTE COCHERE

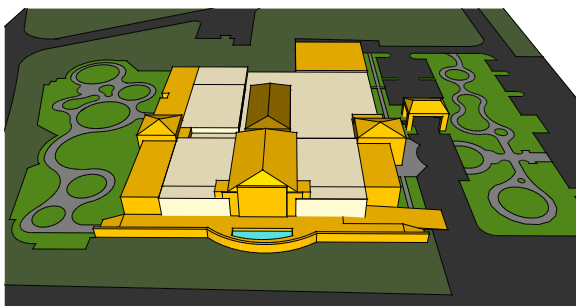
2007-2010
ADDITION OF THE ALICE AND JIM
BECKWITH SCULPTURE GARDEN (2007)
AND EXPANSION OF THE BECKWITH
SCULPTURE GARDEN (2010)

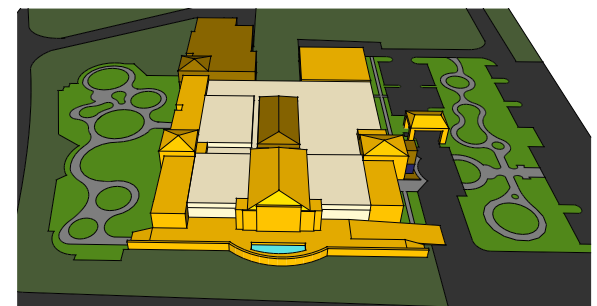
2012-CURRENT
ADDITION OF THE
EXHIBITION BUILDING (2012)

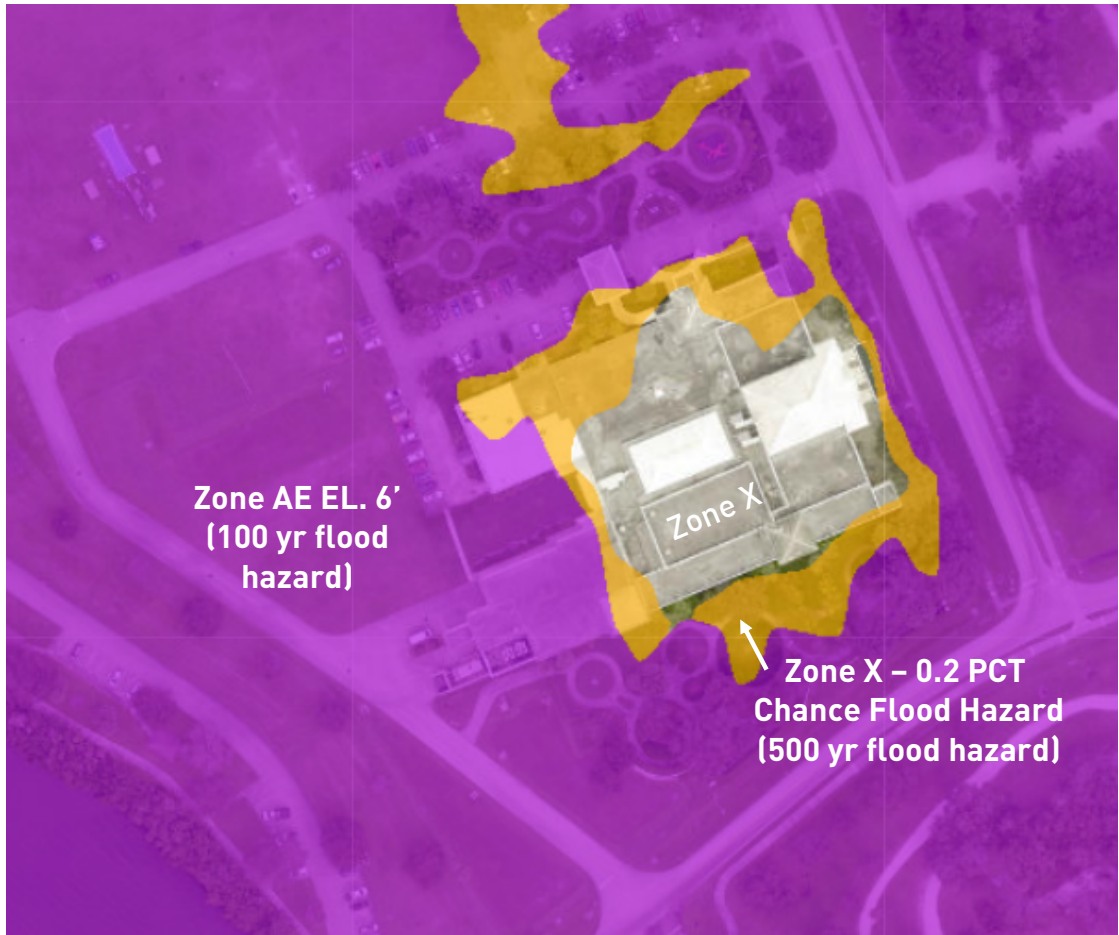
FEMA SPECIAL FLOOD HAZARD AREA MAP 100 YEAR & 500 YEAR (PROPOSED MAP)

FEMA Preliminary Flood Areas

Preliminary Special Flood Hazard Areas (9/29/2017)

- Zone A
- Zone AE (100 year flood hazard)
- Zone AO
- Zone VE
- Zone AE: Floodway
- Zone X: 0.2 Pct Annual Chance Flood Hazard (500 year flood hazard)
- Zone X: Area of Minimal Flood Hazard
- Open Water

*VBMA FFE (1st Floor) = 7.14 ft.
(13.86" (or 1.14') Above 100 year
flood hazard)*

For simplicity of site evaluation, one can look at the delineation of the 100-year flood zone which in the area is a floor 6' above sea level. The first finished floor (FFE) for VBMA is at 7.14', which is 13.68 inches (or 1.14 feet) above the 100 year flood zone (1% chance of flooding within any given year). Represented in the next FEMA graphic, the existing museum is indicated as mostly out of the flood zone but does show some encroachment. This graphic produced by FEMA does not account for knowledge of the exact finish floor elevation. Most of the museum is indicated in Zone "X", however, the graphic depicts some of the existing floor area encroaching into Zone "AE". Since the existing museum 1st floor is uniform at EL 7.14', it is safe to assume the entire finished portion of the building lies out of the 500-yr flood zone.

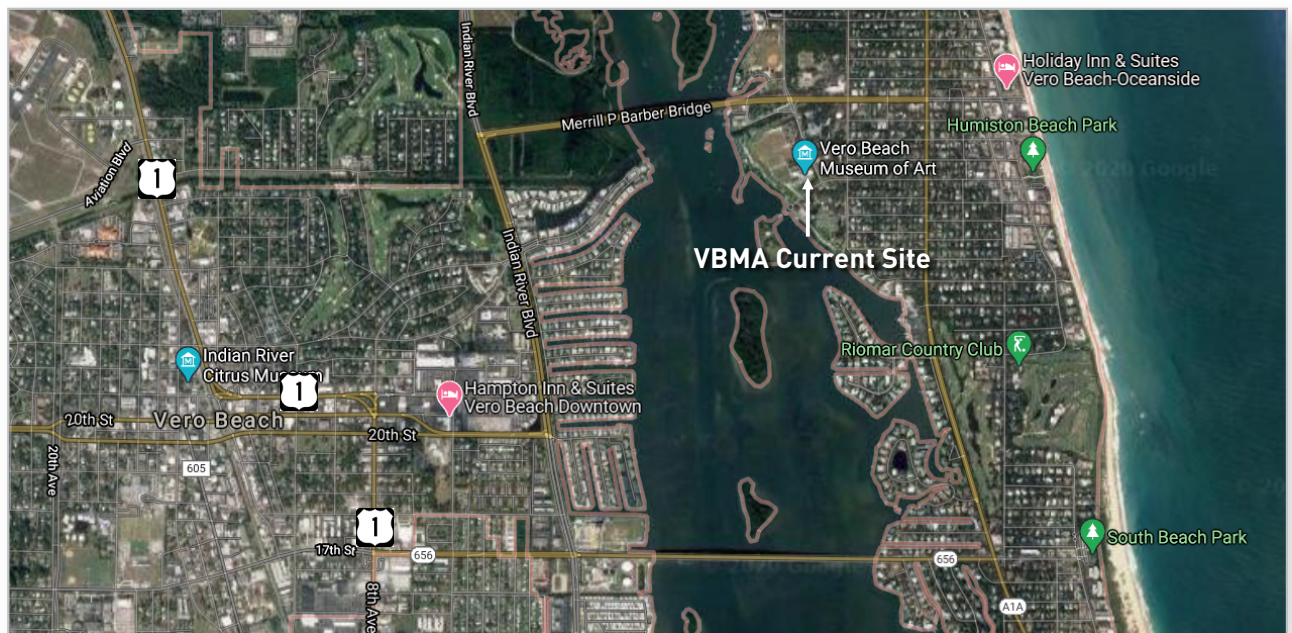
NEW FACILITY INLAND

Hazard	Mitigation Recommendation	Level of Protection
Wind	Address per building code	Per building code for Level IV facilities
Flood	None	Outside of all special flood zones
Storm Surge	Elevate finished floor elevation using added infill (approximately 5')	Protects to a Cat 4 level storm surge (up to 14')

First and most rational cost option is consideration at a site on the mainland to relocate the current facility. The potential site would sit away from the direct impacts of climate hazards associated with the current site on the barrier island. Most reasonable locations for this purpose of this analysis would fall into the Cat 4 storm surge zone and currently sits at an elevation of around 9 feet. Inland sites also typically are located outside of the special flood hazard zones that the museum currently sits within. When one considers this alternative, further mitigation of the climate risk for inland option which would include the new facility being built with an added level of infill of approximately 5' (combination of fill and structure) to raise the FFE to an appropriate level above Cat 4 storm surge flood levels (up to 14'). The mitigation for this facility does not include preventing up to Cat 5 hurricanes. In order to achieve this level of protection, you would need to consider an elevated structure with parking/storage below acting as a "sacrificial floor" for catastrophic storm surge,
